Reconstruction of the Grenfell Tower Fire—Thermomechanical Analysis of Window Failure During the Grenfell Tower Disaster

Maxime Koohkan, Virginie Dréan, Bertrand Girardin, Eric Guillaume and Xavier Duponchel, Efectis France, route de l'Orme Des Merisiers, 91193 Saint Aubin Cedex, France*

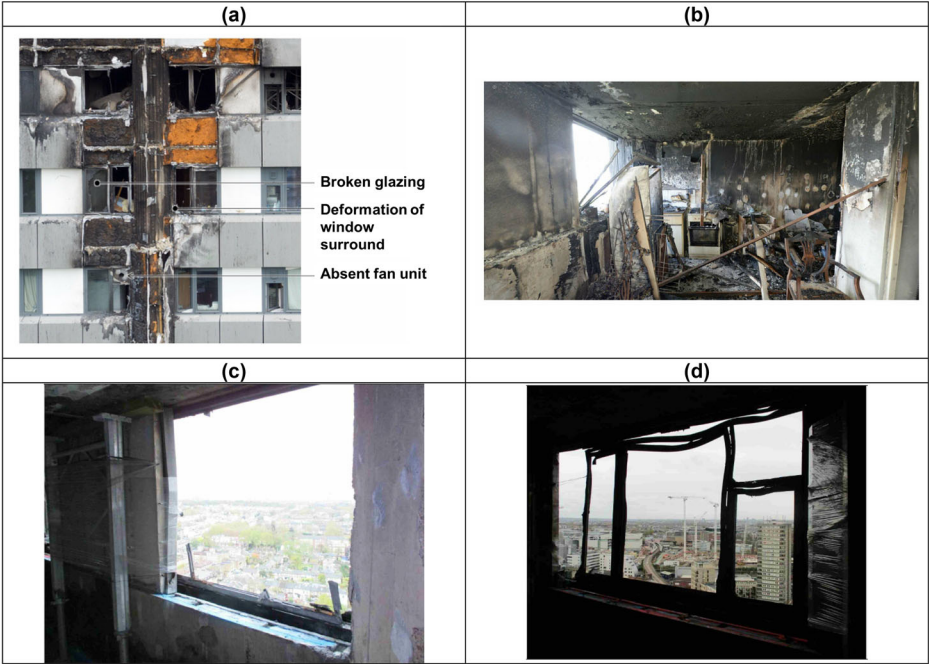
Post-fire observations have shown different failure modes for the windows: inward fallout, outward fallout and partial failure exist at several locations on the Tower. Examples of inward and outward fallout of windows are visible in Fig. 3. However, all the failure modes are quite binary since we observe either a window still in place or no more window.

The failure of the window can also be due, at first, to the softening and/or melting of the uPVC reveal liner, between the window and the concrete structure, when exposed to heat from the external cladding fire, or to thermally induced breakage of the window glazing. Thus, window fallout was probably not the only way of flame exit and re-entry during the Grenfell disaster. However, the failure

Figure 3. a Failure mode of window frame, L. Bisby’s expert report [30], Fig. 11, p. 166, b Inward failure of window frame, J. Torero’s expert report [32], Fig. 54, p. 91, c Outward failure of window frame, B. Lane’s expert report, Appendix C [31], Table 11C, p. 94, d Partial failure of window frame, B. Lane’s expert report, Appendix C [31], Table 11C, p. 95.

of the window is the phenomenon that led to the most significant influx of smoke and fire effluents into the apartments.

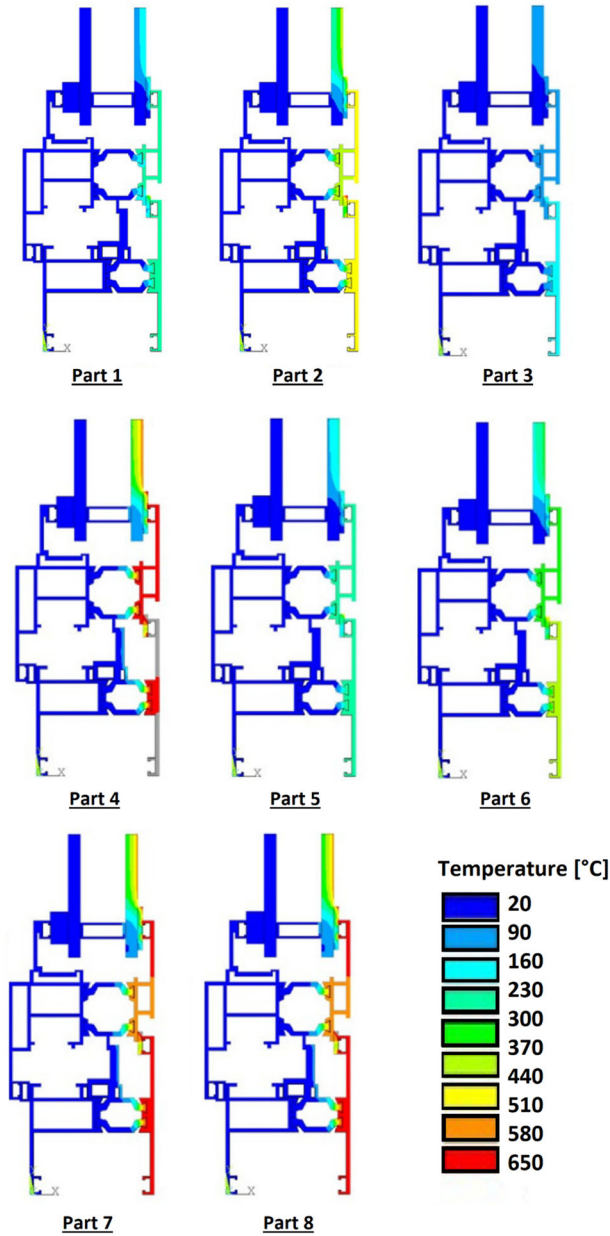
The thermal fields at all sides of the window frame at 180 s (3 min) of fire exposure are addressed in Fig. 13. The temperature is at about the melting point (650°C) at the exposed side of Parts 4, 7 and 8. The results show also that the

exposed side of the window has been melted at all parts except Part 3 before about 4 min.

◀ **Figure 13. Temperature fields for different locations in the window frame at 180 s of fire exposure.**

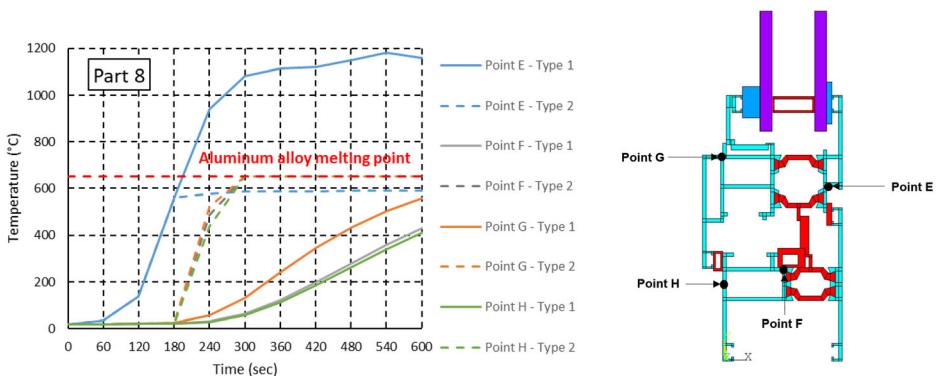
Figure 15 shows the comparison between the temperatures at different points of the window frame for the two types of thermal analysis described above. The temperature is higher than the aluminium alloy melting point (with upper limit of 650 °C) at 180 s for point E for analysis type 1. However, the analysis type 2 assumes that the external profile of the window fails and the temperature at this point does not increase anymore. On the contrary, the computations show that the temperatures are higher after 180 s for points F, G and H. The results of thermal analysis show that the failure of the internal profile of the window frame occurs at about 4 min (250 s), because of aluminium alloy melting.

Figure 15. Evolution of temperature at exposed and on exposed side of frame part 1 at 600 s of fire exposure for two types of thermal analysis.

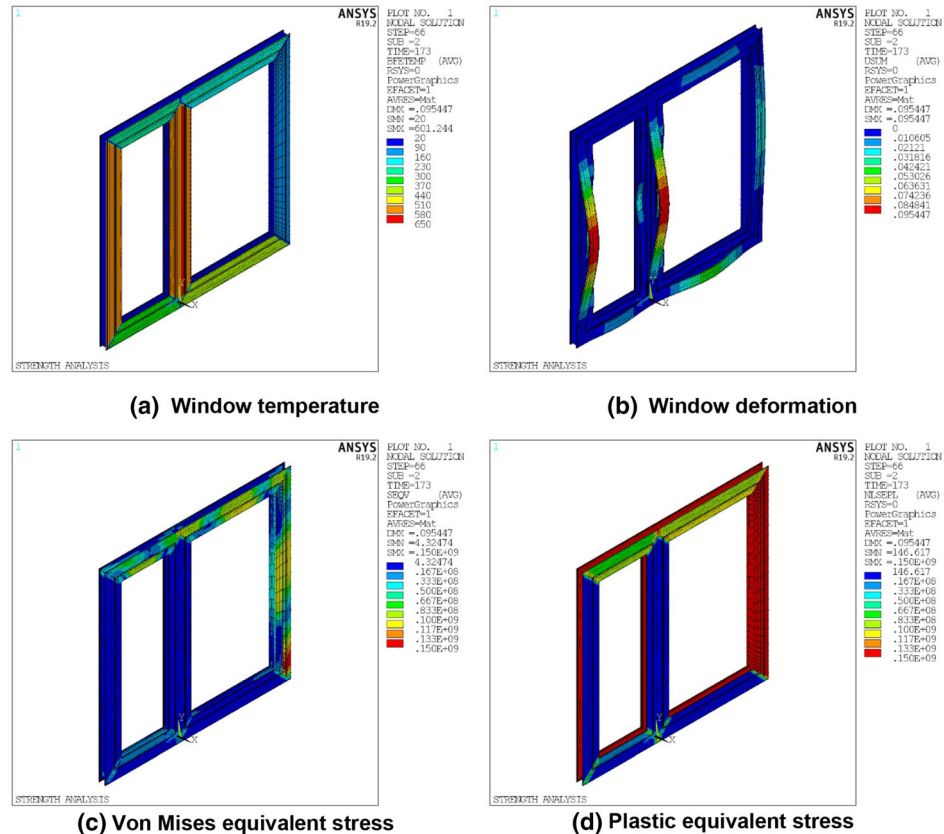
The thermomechanical modelling shows high deformation of the external profile of the window at about 3 min (173 s).

Figure 18. Frame temperature (a), deformation (b), Von Mises stress (c) and plastic equivalent stress (d) before the failure of the outer frame at 173 s of fire exposure for the closed window configuration.

Figure 18a gives the temperature of different Parts of window. These temperatures are computed by 2D thermal analysis. The temperature is almost uniform through the Aluminium thickness. The temperature fields are mapped from the 2D thermal model to the 3D mechanical model in 56 layers through the cross sections for each Part of the window. The temperature on the left side of the frame is indeed lower than the one on the middle component. This is due to the presence of the column located nearby the left part of the window. The vertical flames venting out the lower flat window are impinging the façade above but are deviated by the column having a triangular shape. The flames reattached to the column, leading to lower temperature on the left side of the window that can be considered “shaded” while the flame attached along the column. Convective effects are thus enhanced at this location. The vertical outer profiles of the frame are deformed and may be detached from the rest of the structure because of the large deflections as shown in Fig. 18b. The left side of the exposed frame plasticised because of the thermal stress (Fig. 18c). Aluminium alloy’s yield stress decreases at high temperature. The material resistance is totally removed at the bottom and left side of the window (Fig. 18d). At this moment, the outer profile of the frame detaches from the rest of the window and falls outward. The dynamic force due to the weight of the outer profile and casement may lead to its outward failure.

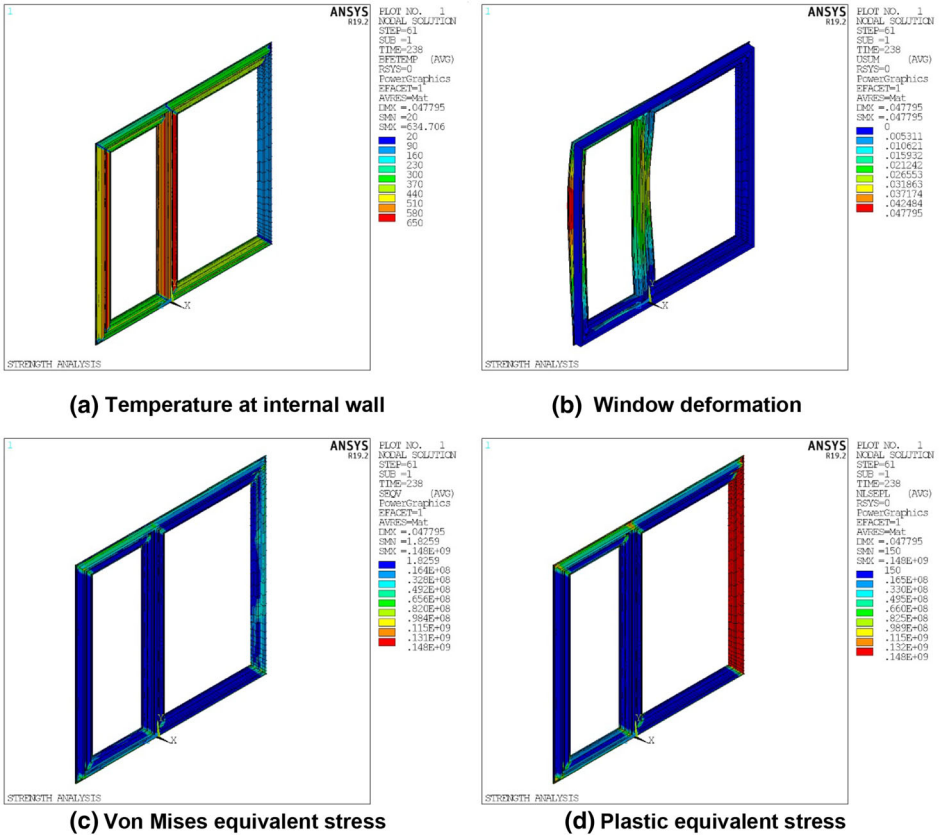
If the external profile of the window collapses without pulling the whole window out, the inner profile will fail inward. The modelling results show the collapse of the inner profile of the frame at about 4 min (238 s) of fire exposure. Figure 19 refers to the temperature, deformed shape, Von Mises stress and plastic equivalent stress for the window before the collapse of the inner profile. The modelling yields a maximum internal profile temperature of up to 600 °C when the failure occurs for the external profile. At this time, almost all of the left side of the structure plasticised, which leads the window collapse.

Figure 19. Frame temperature (a), deformation (b), Von Mises stress (c) and plastic equivalent stress (d) before the failure of the inner frame at 238 s of fire exposure for the closed window configuration.

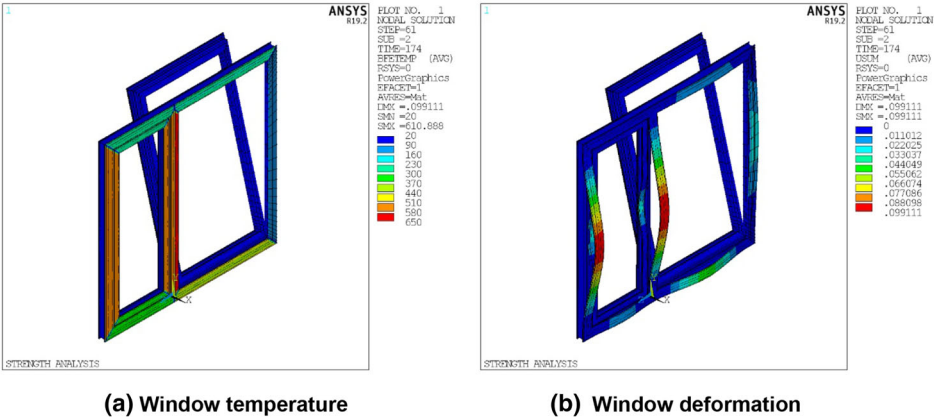
Temperature loads are applied to all Parts of the window except the tilted casement. The outer profile detaches from the rest of the window and falls outward after approximately 3 min (174 s) of fire exposure. The failure mode of the outer profile of the tilted-in configuration is the same as that of the closed window configuration. The maximum temperature at failure time is about 610 °C on the central vertical frame Parts (Parts 4 & 7). Figure 20 shows that the vertical frame Parts are deformed and may be detached from the rest of the structure because of the large deflections. The left side of the exposed frame plasticised because of the thermal stress. However, the failure of the outer profile of the window does not cause the failure toward outside because the weight of the tilted-in casement stabi-

Figure 20. Frame temperature (a) and deformation (b) before failure of outer frame at 174 s of fire exposure for the in-tilt window configuration.

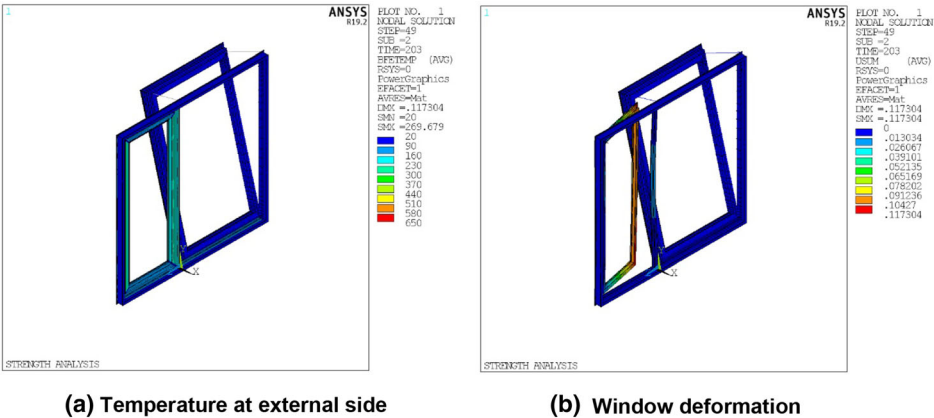
The inner profile will collapse inwards. Modelling shows that the window is deformed and the side-hung casement opens toward inside at about 3.5 min (203 s) of fire exposure. The opening of the side-hung casement, shown in Fig. 21, may generate additional dynamic force on the window and create the complete failure of the structure at this moment. This scenario may occur because the internal frame cannot resist horizontal loads after removing the external profile. However, the numerical model no longer converges at this point, because of large deformation and numerical instability of the finite element solution.

The hypothesis of collapse due to the opening of the side-hung casement may be rejected, because the temperature field evaluated for the internal profile at this

Figure 21. Frame temperature (a) and deformation (b) before failure of outer frame at 203 s of fire exposure for the tilted-in window configuration.

moment is not too high (about 270 °C) and the aluminium will still resist the loads. In that case, the complete collapse of the window occurs at the melting point of the window frame, at about 4 min.

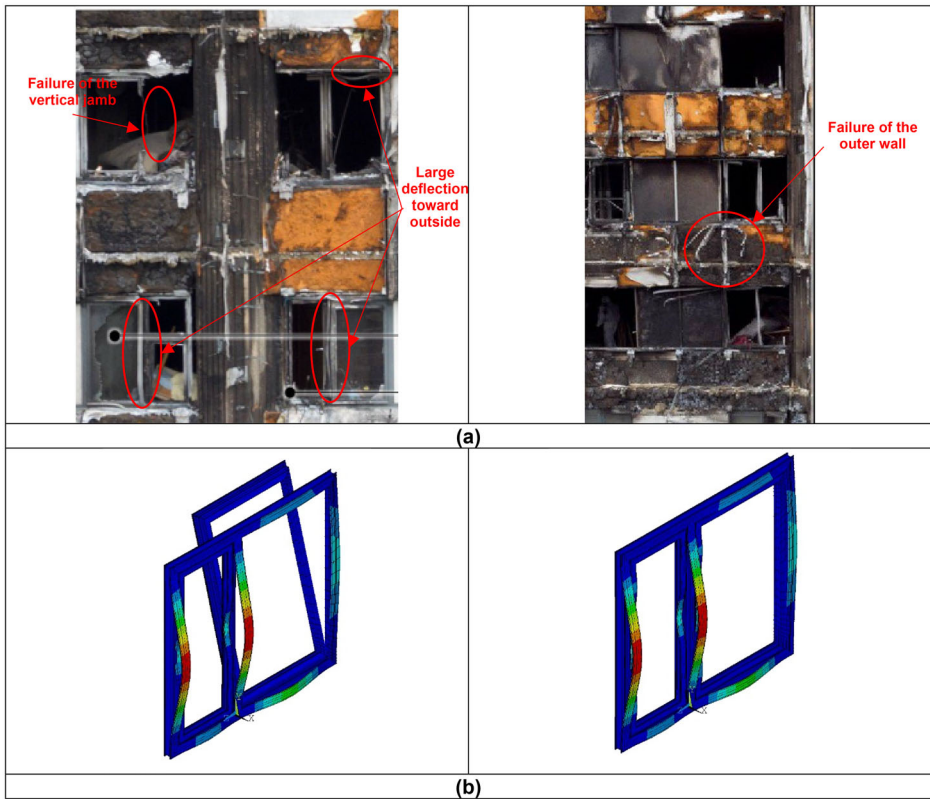
Figure 22. (a) Failure of window frame with outward fallout of the external frame of windows, L. Bisby's expert report [30], Fig. 109 and 110, p. 166, (b) outward failure of window frame evaluated numerically for two opening configurations.

The numerically modelled thermomechanical deformation of the window frames are compared with observations after the real fire in Fig. 22. Partial failures of windows are visible, with the external part of the frame detached from the window and falling outward. Large deflections of vertical or horizontal Parts of the frame occurred during the Grenfell Tower disaster. The numerical model yields the same behaviour, whatever the opening configuration of the window.

The results of the thermomechanical analysis for the window failure times are collated in Table 4. The first failure of the window frame is observed after 3 min of fire exposure and the frame falls toward the exterior. The complete failure of window occurs at about 4 min. The last failure may be at about 5 min as the heating is delayed about 1 min for some of the external profiles. However, even if
